## **Inspector's Daily Report**

IDR Sheet	1	of .	2	Sheets	Final Record Book	Page
Contract			Day			Date
C-7852				We	ednesday	July 7, 2010

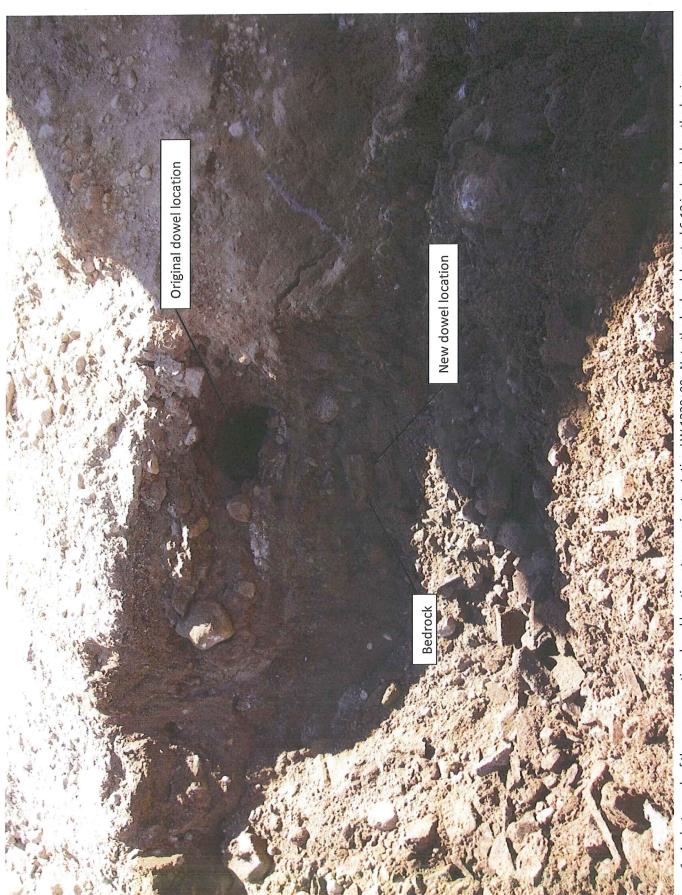
I arrived on-site around 11:00 am and met with Norm Norrish and Brad Schut to discuss the pre-excavation dowel located at approximate station LW 1320+00. Brad had indicated the previous day that the drilling did not encounter any bedrock at that location. I stated that Brad should have a test pit dug at that location to locate the top of bedrock. No test pits were dug when I arrived on-site so we had an excavator dig a test pit at approximate station LW 1320+00 and bedrock was encountered within 12 inches of the original dowel hole (Figure 1). Apparently, the dowel boring was drilled just above the overburden/bedrock contact. I indicated to Brad that an additional dowel should be drilled in the newly exposed bedrock.

Figure 1. A photograph of the pre-excavation dowel location at approximate station LW 1320+00. Note the bedrock located 6-12 inches below the boring.

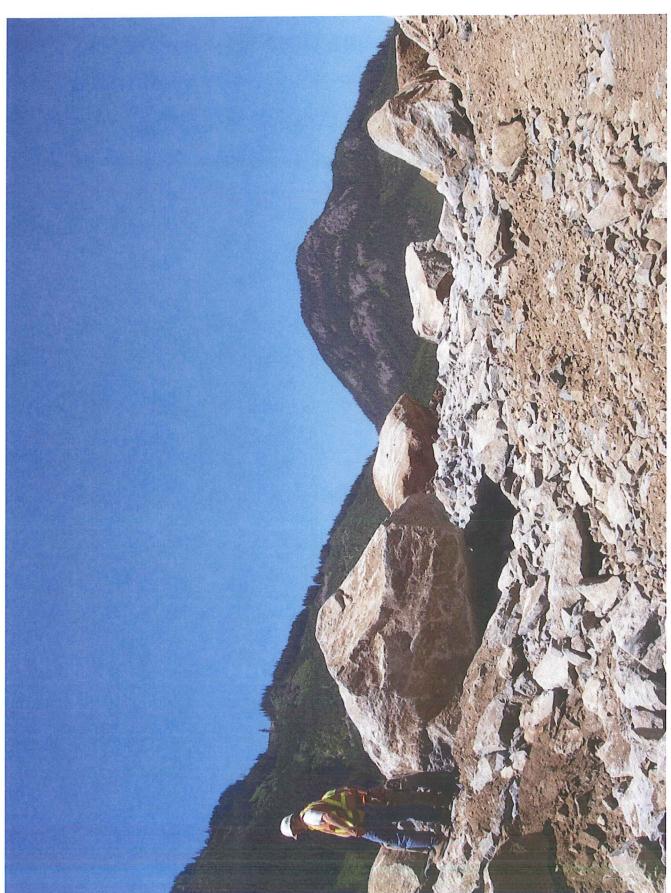
Brad, Norm and I walked to approximate station LW 1337+00 where the first production blast was located. Approximately 6 feet of the first lift was exposed and many oversized boulders were excavated during mucking operations (Figure 2). The mucking had stopped and the oversized boulders were drilled and going to be broken down with small blasts on Thursday night (7/8/2010). Norm and I inspected the exposed wall and it appeared to be average to less than average quality, as expected at the top of the cut (Figure 3); however, we stated to Brad that we also expected the rock to tighten up and increase the quality with depth. Norm and I indicated to Brad that we needed to inspect the full 12 foot lift before we laid out the next row of pattern dowels and any bolts or dowels that needed to be located in the upper 12 feet of the cut. Brad stated that he expected mucking operations to continue on Friday following Thursday night's blasting of the oversized boulders.

Norm and I discussed the oversized blocks with Charley Murphy (contractor blasting consultant) and he indicated that he used 8' of stemming material for the first blast and he expected that future blasts would not produce the oversized blocks. Charley also indicated that he was looking into blasting the nested boulders located upslope of approximate station LW 1335+00. Charley stated that he would most likely be using a "shaped" charge which is similar to a surface charge; however, it has more of a directive energy blast than a surface charge. He indicated he would turn in a submital for the "shaped" charge soon.

Figure 2. A photograph at approximate station LW 1337+00 of the oversized boulders produced during mucking of the first production blast.

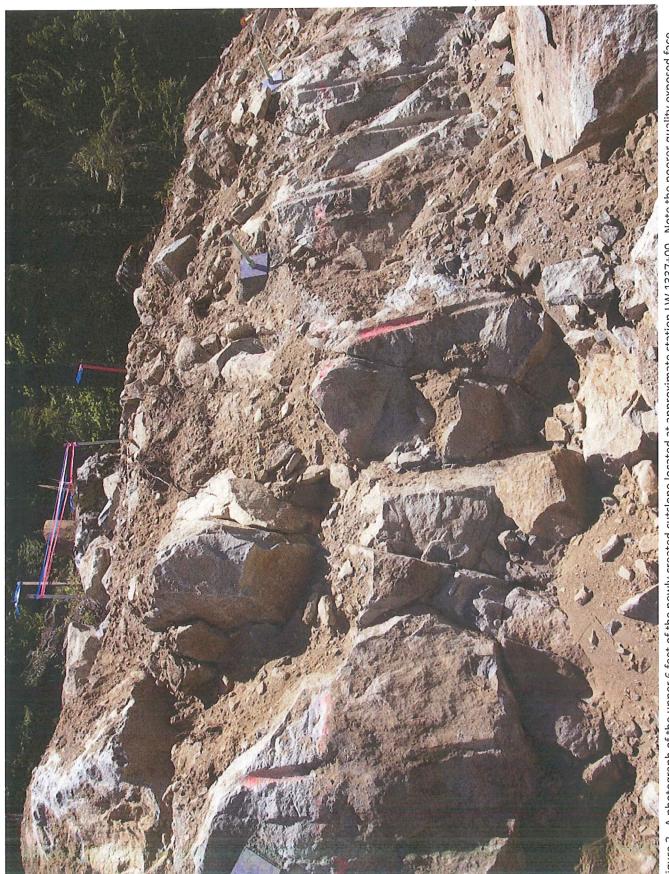
Figure 3. A photograph of the upper 6 feet of the newly created cutslope located at approximate station LW 1337+00. Note the poorer quality exposed face (voids and loose blocks).

Norm indicated that he would send photos of the upper 6 feet of the lift to Gerry Dilley for any comments or concerns he may have from the first blast and upcoming blasts.
